**Flood Control Project Maintenance  
Levee Inspections**

**Fall 2018 Levee Maintenance Deficiency Summary Report**

**Sacramento River Basin**

**Flood Control Project Maintenance  
Levee Inspections****LMA District Cover Sheet****Fall 2018 Levee Inspection Results****Reclamation District No. 0003 Grand Island**

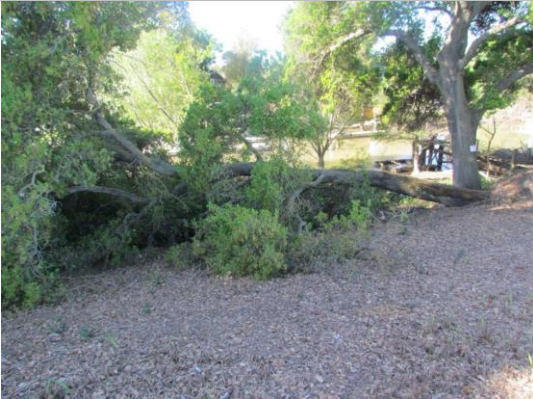
Photo 3 of 3 : FA\_2018\_RD0003\_25\_130\_20180925\_00093.jpg

Looking south at fallen tree on waterward slope.

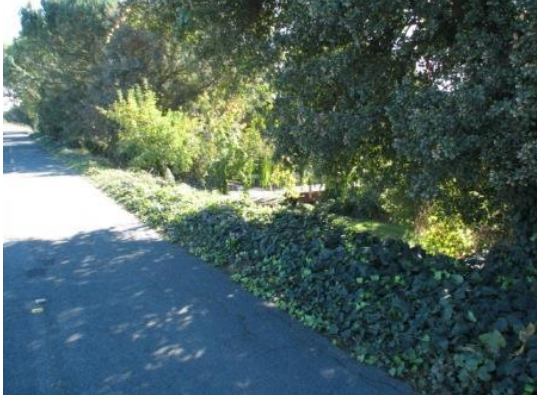
Photo 1 of 1 : FA\_2018\_RD0003\_25\_70\_20180925\_00050.jpg

Landscaping on levee slope obstructs visibility and access.

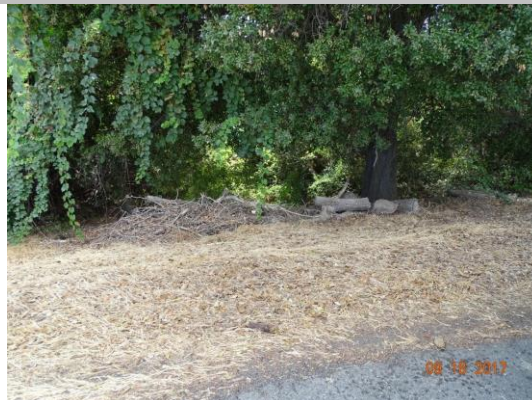
Photo 1 of 2 : FA\_2018\_RD0003\_25\_140\_20180925\_00108.jpg

LM Start	2.01	Rating **	M	Issue No.	140
LM End	2.01	Issue Type +	Ma	Location *	WS
Category	Earthen Levee			GPS Latitude/Longitude	
				Start	End
Item	Encroachments			38.165740 °	38.165740 °
				-121.619970 °	-121.619970 °
DWR ID	DWR_RD0003_02_f_2015_140				
Comment Code					
PR : Prunings					
Inspector Comment					
Remove pruning pile on waterside slope.

Looking south at the waterside slope.

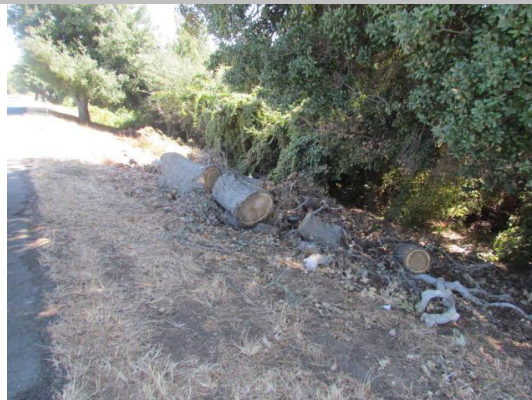
Photo 2 of 2 : FA\_2018\_RD0003\_25\_140\_20180925\_00109.jpg

LM Start	2.01	Rating **	M	Issue No.	140 (cont)	
LM End	2.01	Issue Type +	Ma	Location *	WS	
Category	Earthen Levee			GPS Latitude/Longitude		
				Start		End
Item	Encroachments			38.165740 °		38.165740 °
				-121.619970 °		-121.619970 °
DWR ID	DWR_RD0003_02_f_2015_140					
Comment Code						
PR : Prunings						
Inspector Comment						
Remove pruning pile on waterside slope.

Looking at tree branches and tree limbs on waterward shoulder and slope.

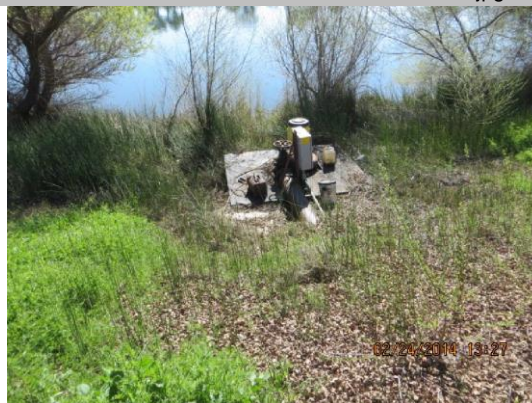
Photo 1 of 3 : UCIP\_FA\_2018\_31026\_56909.jpg

Comment Code						
Inspector Comment						
FS_ID:31026 DS_ID:22211 EP_NO: 2986 Repair Type: Non-Urgent Crossing Status: Found UCIP Comments: Trench over pipe on LS toe may indicate damage to pipe. Repair pipe and fill trench. FIELD_STRUCT_DESC: 12-inch steel irrigation discharge pipe through the levee, 5 feet below the crown. Pump and gate valve on the waterside (WS) slope. 42-inch concrete standpipe at the landside (LS) toe. 1.5-inch steel electrical conduit through the levee at the same location. (Plans for installation of a pumping plant on the levee authorized under Permit No. 2986, 1959 - Ike Craven). [Additional Reference(s): DWR Levee Log, 1993. USACE Sacramento O&M Manual 104, February 1960, (RM 17.25), referenced as invert elevation 4 feet below the crown]. FS Date: 2/24/2014

Pump, pipe, gate valve, and electrical conduit visible on WS slope.

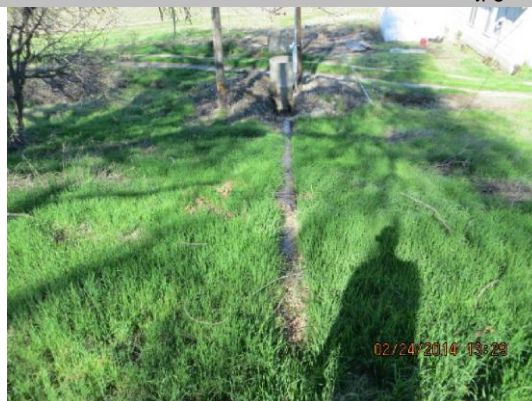
Photo 2 of 3 : UCIP\_FA\_2018\_31026\_56908.jpg

Comment Code						
Inspector Comment						
FS_ID:31026 DS_ID:22211 EP_NO: 2986 Repair Type: Non-Urgent Crossing Status: Found UCIP Comments: Trench over pipe on LS toe may indicate damage to pipe. Repair pipe and fill trench. FIELD_STRUCT_DESC: 12-inch steel irrigation discharge pipe through the levee, 5 feet below the crown. Pump and gate valve on the waterside (WS) slope. 42-inch concrete standpipe at the landside (LS) toe. 1.5-inch steel electrical conduit through the levee at the same location. (Plans for installation of a pumping plant on the levee authorized under Permit No. 2986, 1959 - Ike Craven). [Additional Reference(s): DWR Levee Log, 1993. USACE Sacramento O&M Manual 104, February 1960, (RM 17.25), referenced as invert elevation 4 feet below the crown]. FS Date: 2/24/2014

Pipe, meter, power pole, and concrete standpipe visible on LS slope/toe.

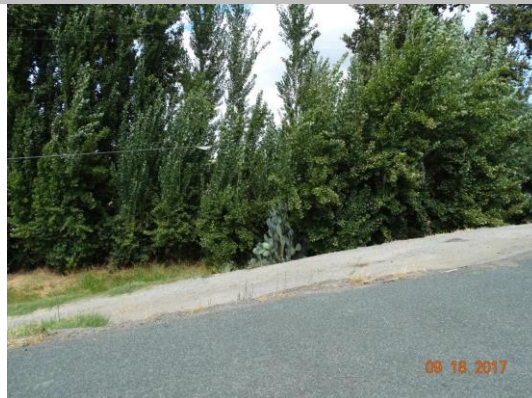
Photo 1 of 2 : FA\_2018\_RD0003\_25\_30\_20180925\_00027.jpg

LM Start	2.44	Rating **	M	Issue No.	30
LM End	2.44	Issue Type +	En	Location *	LS
Category	Earthen Levee			GPS Latitude/Longitude	
				Start	End
Item	Vegetation			38.164379 °	38.164379 °
				-121.612455 °	-121.612455 °
DWR ID	DWR_RD0003_02_f_2013_30				
Comment Code					
V6 : Landscaping					
Inspector Comment					
Cactus at landside toe and berm.

Looking north at the landside slope.

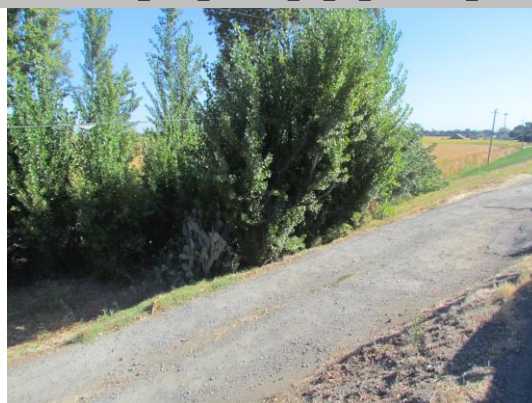
Photo 2 of 2 : FA\_2018\_RD0003\_25\_30\_20180925\_00028.jpg

Looking northeast at cactus and untrimmed trees at landward toe.

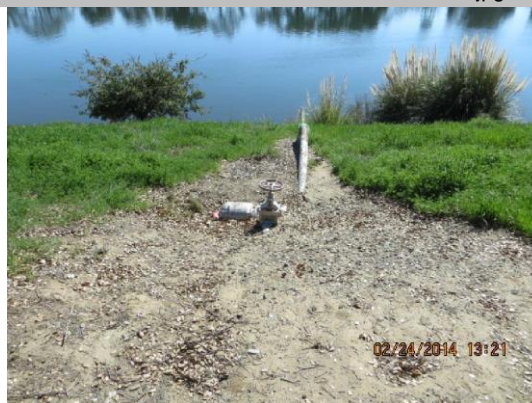
Photo 1 of 3 : UCIP\_FA\_2018\_31025\_56906.jpg

Comment Code					
Inspector Comment					
FS_ID:31025 DS_ID:22212 EP_NO: 1289 Repair Type: Non-Urgent Crossing Status: Indicator Found UCIP Comments: Appears abandoned and if so should be done so properly. FIELD_STRUCT_DESC: *ABANDONED* 6-inch steel irrigation discharge pipe through the levee, invert elevation 4.5 feet below the crown. Pump and gate valve on the waterside (WS) slope. Service pole on the landside (LS) with a 1.5-inch electrical conduit through the levee at the same location. (Plans for installing an irrigation pumping plant and a 6-inch steel pipe through the levee authorized under Permit No. 1289, 1948 - Carlos Silva). [Additional Reference(s): DWR Levee Log, 1993. USACE Sacramento O&M Manual 104, February 1960, (RM 17.56)]. FS Date: 2/24/2014

Pipe, pump, and gate valve on WS slope.

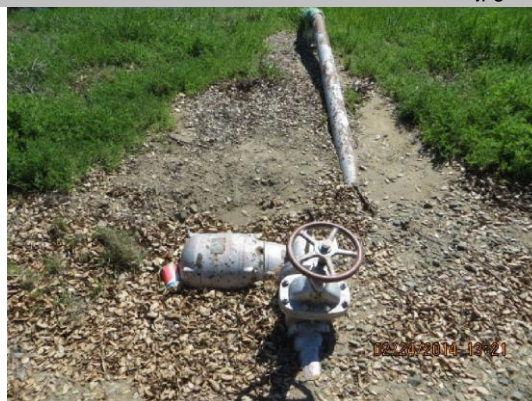
Photo 2 of 3 : UCIP\_FA\_2018\_31025\_56905.jpg

Comment Code						
Inspector Comment						
FS_ID:31025 DS_ID:22212 EP_NO: 1289 Repair Type: Non-Urgent Crossing Status: Indicator Found UCIP Comments: Appears abandoned and if so should be done so properly. FIELD_STRUCT_DESC: *ABANDONED* 6-inch steel irrigation discharge pipe through the levee, invert elevation 4.5 feet below the crown. Pump and gate valve on the waterside (WS) slope. Service pole on the landside (LS) with a 1.5-inch electrical conduit through the levee at the same location. (Plans for installing an irrigation pumping plant and a 6-inch steel pipe through the levee authorized under Permit No. 1289, 1948 - Carlos Silva). [Additional Reference(s): DWR Levee Log, 1993. USACE Sacramento O&M Manual 104, February 1960, (RM 17.56)]. FS Date: 2/24/2014

Pump and gate valve on WS slope.

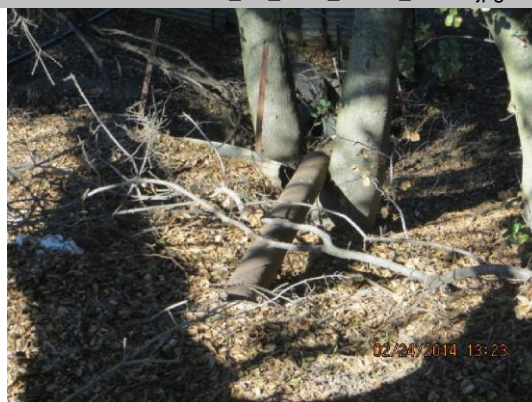
Photo 3 of 3 : UCIP\_FA\_2018\_31025\_56904.jpg

Pipe on LS slope.

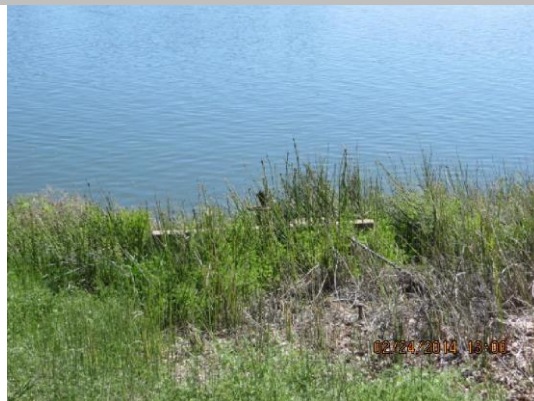
Photo 1 of 3 : UCIP\_FA\_2018\_30983\_56877.jpg

Comment Code						
Inspector Comment						
FS_ID:30983						
DS_ID:22217						
EP_NO: N/A						
Repair Type: Non-Urgent						
Crossing Status: Found						
UCIP Comments: Pipe appears abandoned and if so should be done so properly.						
FIELD_STRUCT_DESC: 6-inch steel irrigation discharge pipe through the levee, invert elevation 3.5 feet below the crown. Pump and gate valve on a concrete pad on the waterside (WS) slope. Meter pole at the landside (LS) toe with a 1.5-inch electrical conduit through the levee at the same location. (Lillie). [Additional Reference(s): DWR Levee Log, 1993. USACE Sacramento O&M Manual 104, February 1960, (RM 18.17)].						
FS Date: 2/24/2014

Pump on concrete platform on WS slope.

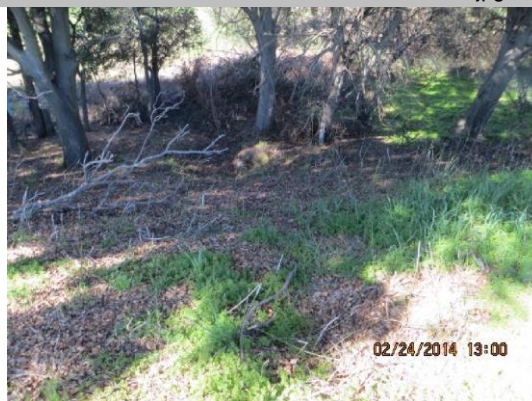
Photo 2 of 3 : UCIP\_FA\_2018\_30983\_56876.jpg

Comment Code						
Inspector Comment						
FS_ID:30983						
DS_ID:22217						
EP_NO: N/A						
Repair Type: Non-Urgent						
Crossing Status: Found						
UCIP Comments: Pipe appears abandoned and if so should be done so properly.						
FIELD_STRUCT_DESC: 6-inch steel irrigation discharge pipe through the levee, invert elevation 3.5 feet below the crown. Pump and gate valve on a concrete pad on the waterside (WS) slope. Meter pole at the landside (LS) toe with a 1.5-inch electrical conduit through the levee at the same location. (Lillie). [Additional Reference(s): DWR Levee Log, 1993. USACE Sacramento O&M Manual 104, February 1960, (RM 18.17)].						
FS Date: 2/24/2014

Pipe visible at LS toe.

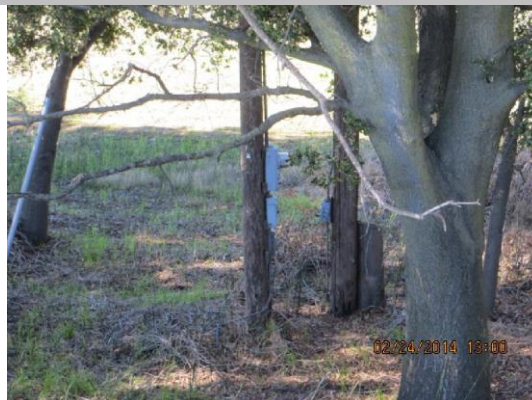
Photo 3 of 3 : UCIP\_FA\_2018\_30983\_56875.jpg

Meter on powerpole on LS toe.

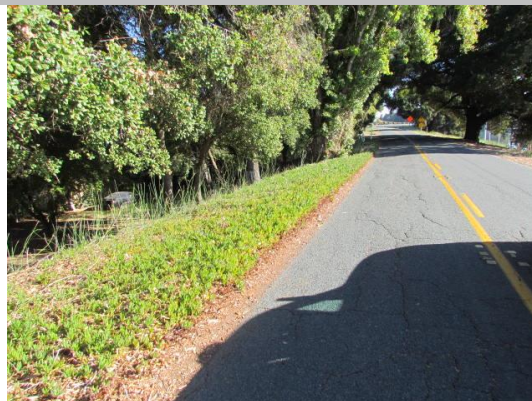
Photo 1 of 1 : FA\_2018\_RD0003\_25\_46\_20180925\_00036.jpg

LM Start	3.33	Rating **	M	Issue No.	46
LM End	3.33	Issue Type +	En	Location *	LS
Category	Earthen Levee			GPS Latitude/Longitude	
				Start	End
Item	Vegetation			38.169061 °	38.169061 °
				-121.597765 °	-121.597765 °
DWR ID	DWR_RD0003_02_s_2012_46				
Comment Code					
V6 : Landscaping					
Inspector Comment					
Iceplant and trees blocking view of landside slope.

Looking northeast at landscaping blocking view of landward slope.

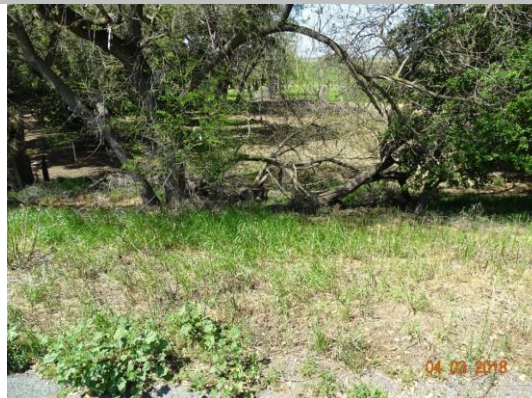
Photo 1 of 1 : FA\_2018\_RD0003\_25\_180\_20180925\_00145.jpg

LM Start	3.44	Rating **	M	Issue No.	180
LM End	3.44	Issue Type +	En	Location *	LS
Category	Earthen Levee			GPS Latitude/Longitude	
				Start	End
Item	Encroachments			38.170293 °	38.170293 °
				-121.596497 °	-121.596497 °
DWR ID	DWR_RD0003_02_s_2018_180				
Comment Code					
TR : Tree or limb					
Inspector Comment					
Fallen tree at landside toe blocks access.

Fallen tree at landside toe should be removed.

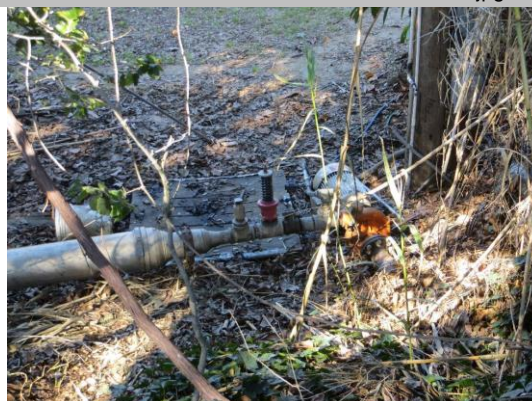
Photo 1 of 3 : UCIP\_FA\_2018\_30963\_56862.jpg

Comment Code						
Inspector Comment						
FS_ID:30963						
DS_ID:22221						
EP_NO: 1283						
Repair Type: Non-Urgent						
Crossing Status: Indicator Found						
UCIP Comments: Permit for 12-inch pipe and pump on pier. Unable to identify permit for 6-inch pipe.						
FIELD_STRUCT_DESC: 12-inch steel irrigation discharge pipe through the levee, invert elevation 6 feet below the crown. Pump, shutoff valve, power pole, and vent at the landside (LS) toe. 6-inch steel pipe appears to be sleeved through the 12-inch pipe. 1.5-inch steel electrical conduit at the same location. (Plans for installing a pumping plant and a 12-inch pipe through the levee authorized under Permit No. 1283, 1948 - Manuel E. and Frank E. Silva). [Additional Reference(s): DWR Levee Log, 1993. USACE Sacramento O&M Manual 104, February 1960, (RM 18.66)].						
FS Date: 2/24/2014

Pump, shutoff, power pole, and vent on LS toe.

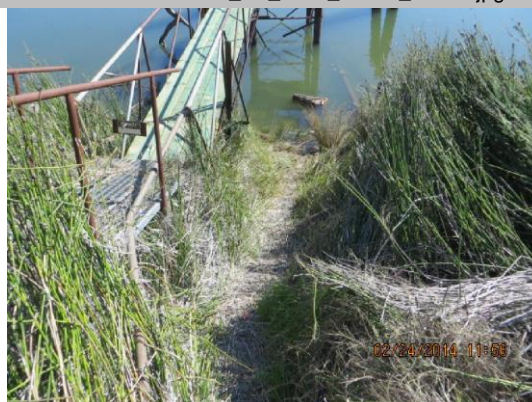
Photo 2 of 3 : UCIP\_FA\_2018\_30963\_56861.jpg

Pipe visible to right of walkway on LS slope and in water.

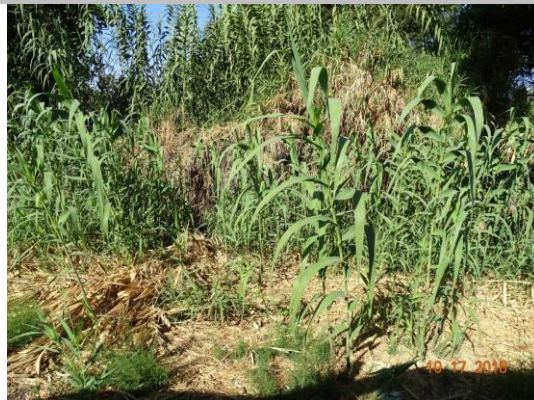
Photo 1 of 1 : FA\_2018\_RD0003\_25\_200\_20181018\_00305.jpg

LM Start	3.78	Rating **	U	Issue No.	200
LM End	3.78	Issue Type +	Ma	Location *	LS
Category	Earthen Levee			GPS Latitude/Longitude	
				Start	End
Item	Vegetation			38.174550 °	38.174550 °
				-121.593345 °	-121.593345 °
DWR ID	DWR_RD0003_02_f_2018_200				
Comment Code					
V2 : Remove the wild growth other than native grasses from the levee slopes.					
Inspector Comment					
Remove new arundo growth.

View of new bamboo growth on the land side slope (October 2018).

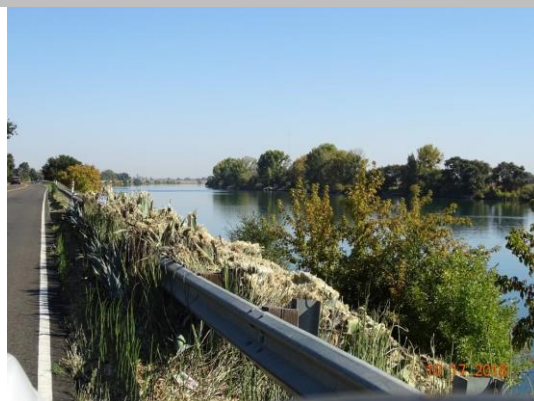
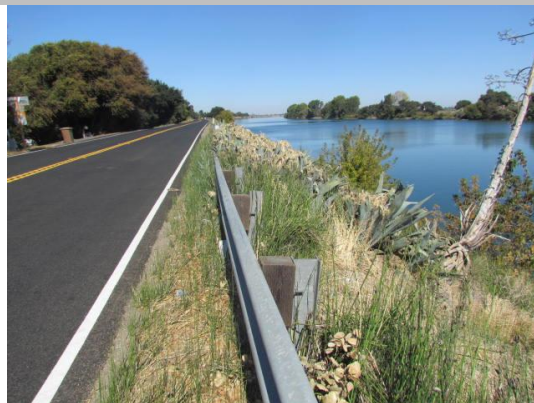
LM Start	4.11	Rating **	A/W	Issue No.	145
LM End	4.11	Issue Type +	Ma	Location *	WS
Category	Earthen Levee			GPS Latitude/Longitude	
				Start	End
Item	Vegetation			38.178779 °	38.178779 °
				-121.590425 °	-121.590425 °
DWR ID	DWR_RD0003_02_f_2015_145				
Comment Code					
V7 : Trees / Woody Vegetation					
Inspector Comment					
Century plants on waterside shoulder and slope have been chopped back.

View of looking upstream at chopped century plants on the water side shoulder and slope (October 2018).

Looking northeast at century plants on waterward shoulder and slope.

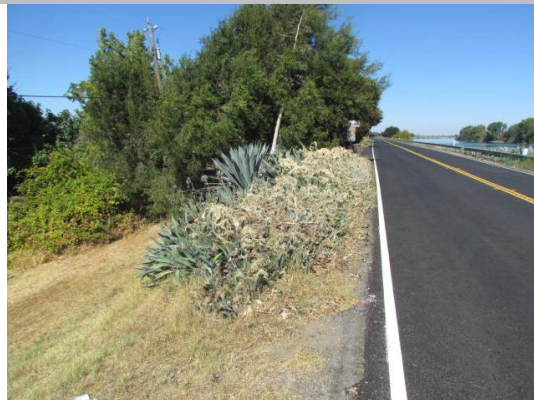
LM Start	4.11	Rating **	U	Issue No.	143
LM End	4.11	Issue Type +	Ma	Location *	LS
Category	Earthen Levee			GPS Latitude/Longitude	
				Start	End
Item	Vegetation			38.178782 °	38.178782 °
				-121.590418 °	-121.590418 °
DWR ID	DWR_RD0003_02_f_2015_143				
Comment Code					
V7 : Trees / Woody Vegetation					
Inspector Comment					
Large century plants on landside shoulder and slope.

Looking north at century plants on landward shoulder and slope.

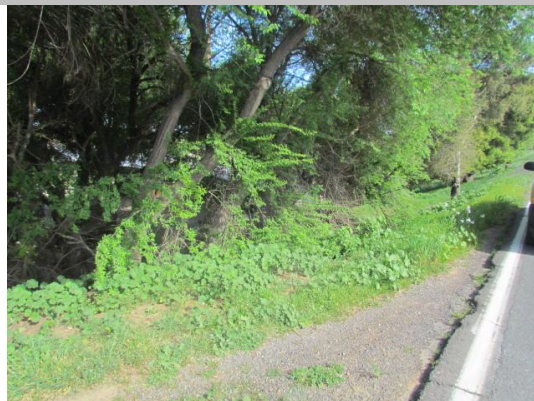
LM Start	4.14	Rating **	M	Issue No.	48
LM End	4.14	Issue Type +	En	Location *	LS
Category	Earthen Levee			GPS Latitude/Longitude	
				Start	End
Item	Vegetation			38.179160 °	38.179160 °
				-121.590247 °	-121.590247 °
DWR ID	DWR_RD0003_02_f _ 2018_48				
Comment Code					
V6 : Landscaping					
Inspector Comment

Looking southwest at dense trees on landward slope.

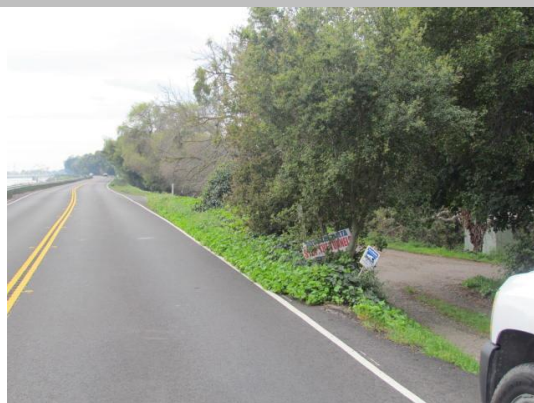
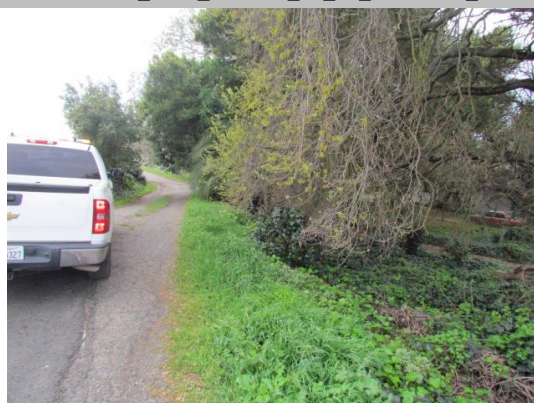
LM Start	4.25	Rating **	U	Issue No.	92
LM End	4.33	Issue Type +	En	Location *	LS
Category	Earthen Levee			GPS Latitude/Longitude	
				Start	End
Item	Vegetation			38.180483 °	38.181540 °
				-121.589119 °	-121.588348 °
DWR ID	DWR_RD0003_02_s_2012_92				
Comment Code					
V6 : Landscaping					
Inspector Comment					
Ground cover, palm tree and other vegetation blocking view of landside slope and toe.

Looking south at groundcover and other vegetation on landward slope.

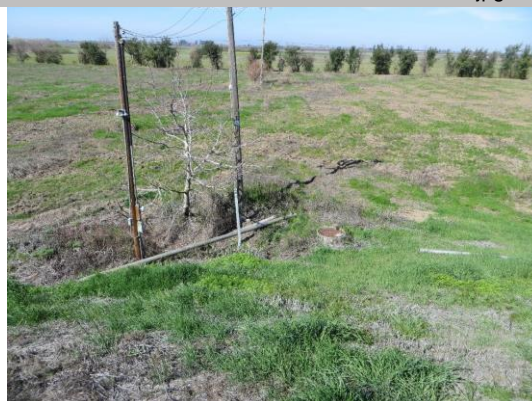
Approximate location of pipe on LS toe.

Comment Code						
Inspector Comment						
FS_ID:53484 DS_ID:22224 EP_NO: N/A Repair Type: Non-Urgent Crossing Status: Found UCIP Comments: 07/20/2018 Everything appears to be the same as last time. Up and over pipe: low flood risk during high water. No integrity issues. Crossing downgraded to "Non-Urgent" because of the conditions listed above. (A. McDonald - DWR UCIP)07/06/2016 Same as last inspection. Open pipe on WS may be partially plugged. Unclear whether open pipe beneath pump platform connects to pump and crossing that rest above platform or if they are two seperate crossings. If they are connected, positive closure device on pump may prevent backflow. Appears abandoned. (DWR UCIP - K. Fazel)02/24/2014 Pipe open on WS toe-visible under pump at WS toe. Pipe abandoned and should be done so properly. (DWR UCIP - G. Wylie) FIELD_STRUCT_DESC: *ABANDONED* 6-inch steel irrigation discharge pipe through the levee, 5.4 feet below the crown. Pipe visible beneath a pump platform on the waterside (WS). Another larger steel pipe (DSID 22223) visible through the WS slope and connected to a centrifugal pump with a closure valve resting over a platform on the WS. 2-inch electrical conduit through the levee at the same location leads to service pole on the landside (LS). [Additional Reference(s): DWR Levee Log, 1993. USACE Sacramento O&M Manual 104, February 1960 (RM 19.39)]. Levee Log mentions the 6-inch pipe is plugged and cut off. FS Date: 7/20/2018

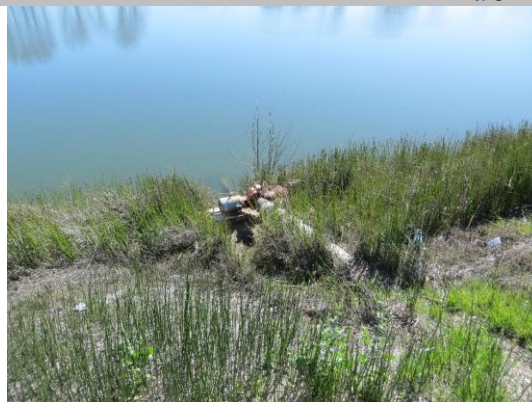
Pipe visible under pump on WS slope.

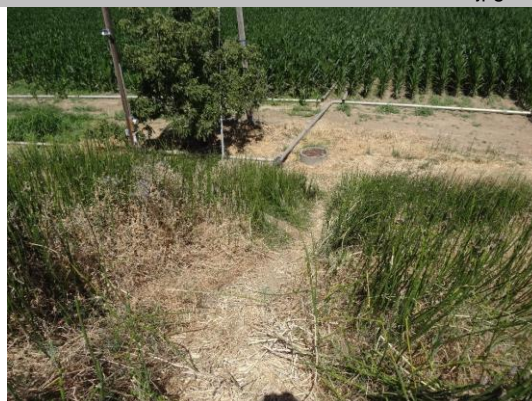
LS view; standpipe and power pole off LS toe.

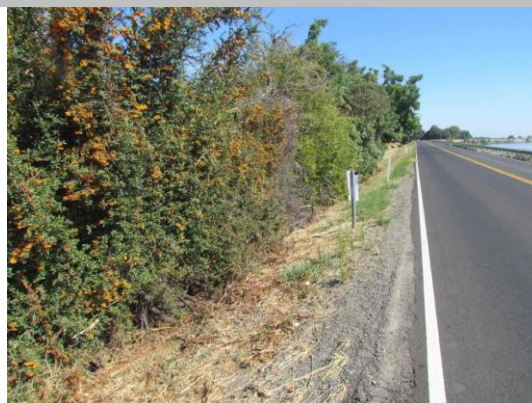
LM Start	4.63	Rating **	A	Issue No.	13
LM End	4.69	Issue Type +	En	Location *	LS
Category	Earthen Levee			GPS Latitude/Longitude	
				Start	End
Item	Vegetation			38.185099 °	38.185737 °
				-121.585131 °	-121.584473 °
DWR ID	DWR_RD0003_02_s_2012_13				
Comment Code					
V6 : Landscaping					
Inspector Comment					
Dense landscaping and vegetation on landside slope and toe.

Looking north at dense vegetation on landward slope.

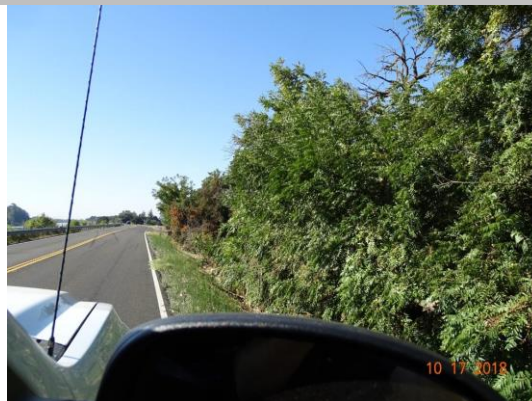
LM Start	4.63	Rating **	U	Issue No.	199
LM End	4.66	Issue Type +	En	Location *	LS
Category	Earthen Levee			GPS Latitude/Longitude	
				Start	End
Item	Vegetation			38.185122 °	38.185430 °
				-121.585165 °	-121.584835 °
DWR ID	DWR_RD0003_02_f_2018_199				
Comment Code					
V6 : Landscaping					
Inspector Comment

View looking downstream at landscaping on the land side slope (October 2018).

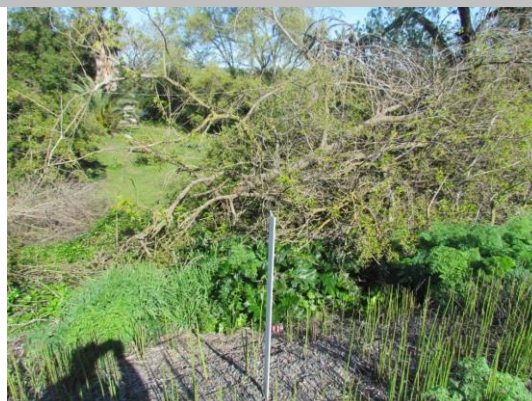
LM Start	4.65	Rating **	U	Issue No.	97
LM End	4.65	Issue Type +	Ma	Location *	LS
Category	Earthen Levee			GPS Latitude/Longitude	
				Start	End
Item	Encroachments			38.185317 °	38.185317 °
				-121.584870 °	-121.584870 °
DWR ID	DWR_RD0003_02_s_2017_97				
Comment Code					
TR : Tree or limb					
Inspector Comment					
Fallen tree on landside slope.

Looking west at fallen tree on landward slope.

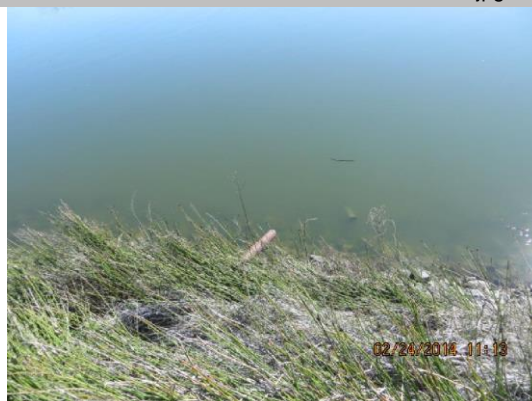
LM Start	4.74	Rating **	M	Issue No.	961
LM End	4.74	Issue Type +	En	Location *	
Category	Supplemental			GPS Latitude/Longitude	
				Start	End
Item	DWR UCIP Field Study			38.186292 °	38.186292 °
				-121.583945 °	-121.583945 °
DWR ID	22227				
Comment Code					
Inspector Comment					
FS_ID:30903					
DS_ID:22227					
EP_NO: N/A					
Repair Type: Non-Urgent					
Crossing Status: Found					
UCIP Comments: Need to verify type of abandonment. Does not appear to have been abandoned properly.					
FIELD_STRUCT_DESC: *ABANDONED* 5-inch steel gravity irrigation pipe through the levee, invert elevation 3.4 feet below the crown. (J. del Costello). [Additional Reference(s): DWR Levee Log, 1993. USACE Sacramento O&M Manual 104, February 1960, (RM 19.63)].					
FS Date: 2/24/2014

Pipe visible at WS toe.

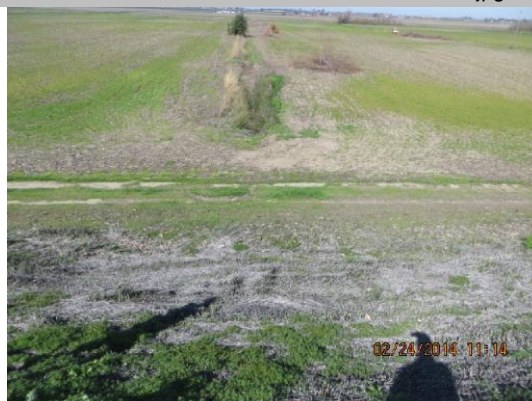
Swale off LS toe likely along same alignment as pipe.

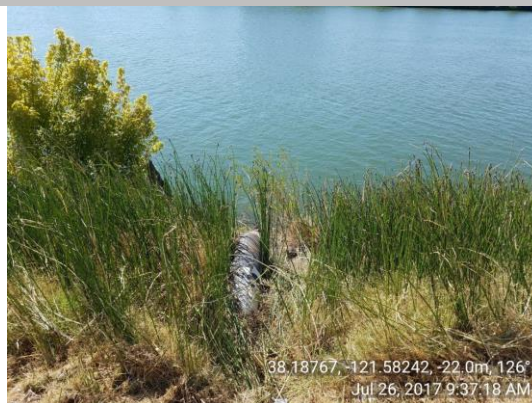
LM Start	4.86	Rating **	A/W	Issue No.	127
LM End	4.87	Issue Type +	Ma	Location *	
Category	Supplemental			GPS Latitude/Longitude	
				Start	End
Item	2017 Storm Damage			38.187528 °	38.187781 °
				-121.582394 °	-121.582331 °
DWR ID	DWR_RD0003_02_f_2017_127				
Comment Code					
Inspector Comment					
Levee Evaluation Comments					
Description:District station 256+60 to 257+96, Sec. 19, T. 4 N. R. 4 E., M.D.M. Approximately 136 linear feet erosion and sloughing exists along the water side slope of the Sacramento River (Unit 2). The erosion commences approximately 1/4 of the way down the slope from the crown and extends to the rip rap.					
Site ID No:278					
Site Designation:LMA-104					
Repair Type: Erosion					
Rating:Area of Concern					
Field Date:7/26/2017					
Notes:

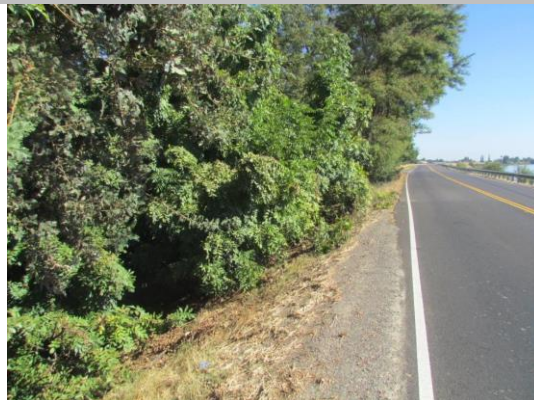
LM Start	4.94	Rating **	M	Issue No.	14
LM End	4.98	Issue Type +	Ma	Location *	LS
Category	Earthen Levee			GPS Latitude/Longitude	
				Start	End
Item	Trim / Thin Trees			38.188344°	38.188748°
				-121.581414°	-121.580743°
DWR ID	DWR_RD0003_02_s_2012_14				
Comment Code					
T1 : Trim trees to at least five feet above ground level.					
Inspector Comment					
Untrimmed trees on landside slope and toe.

Looking northeast at dense vegetation on landward shoulder and slope. (Fall 2016)

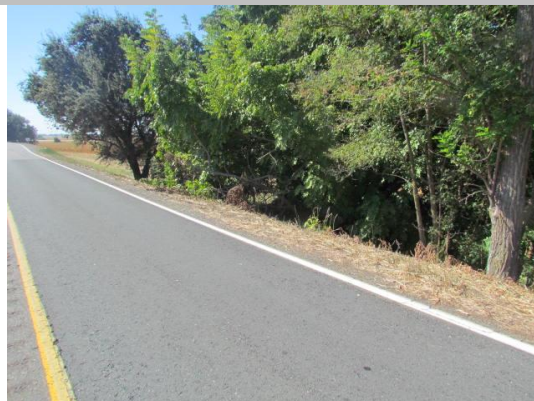
Looking southwest at untrimmed trees on landward toe. (Spring 2016)

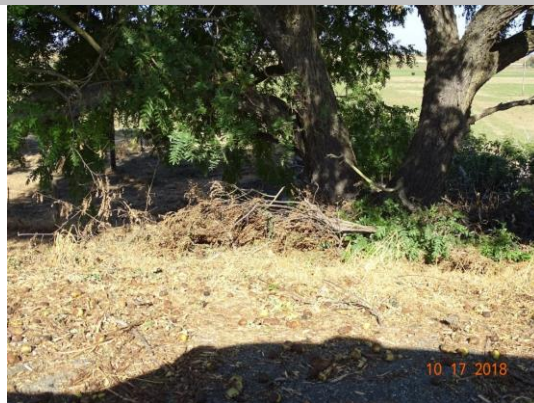
LM Start	5.03	Rating **	M	Issue No.	56
LM End	5.03	Issue Type +	Ma	Location *	LS
Category	Earthen Levee			GPS Latitude/Longitude	
				Start	End
Item	Encroachments			38.189227°	38.189227°
				-121.579983°	-121.579983°
DWR ID	DWR_RD0003_02_f_2018_56				
Comment Code					
TR : Tree or limb					
Inspector Comment					
Remove tree limbs on landside slope.

View of tree limbs on the land side slope (October 2018).

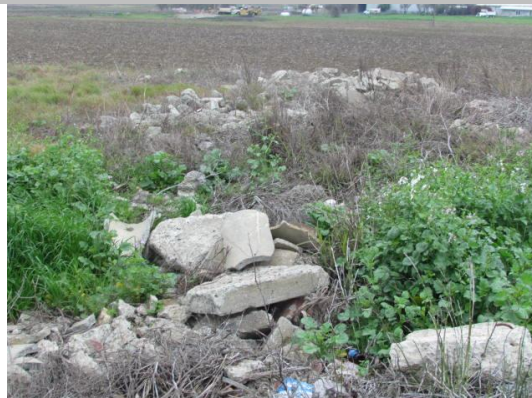
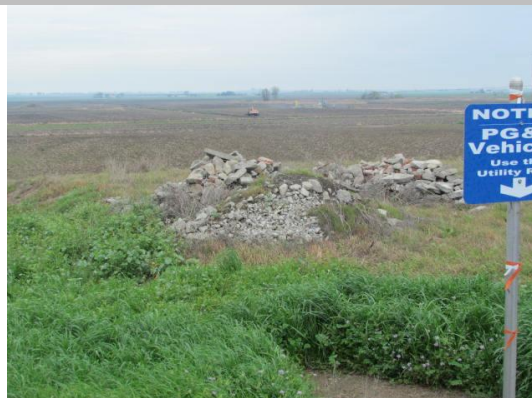
LM Start	5.35	Rating **	M	Issue No.	76
LM End	5.35	Issue Type +	En	Location *	LS
Category	Earthen Levee			GPS Latitude/Longitude	
				Start	End
Item	Encroachments			38.191392°	38.191392°
				-121.574832°	-121.574832°
DWR ID	DWR_RD0003_02_s_2013_76				
Comment Code					
MA : Material					
Inspector Comment					
Concrete rubble on landside slope.

Looking northwest at concrete rubble on landward slope.

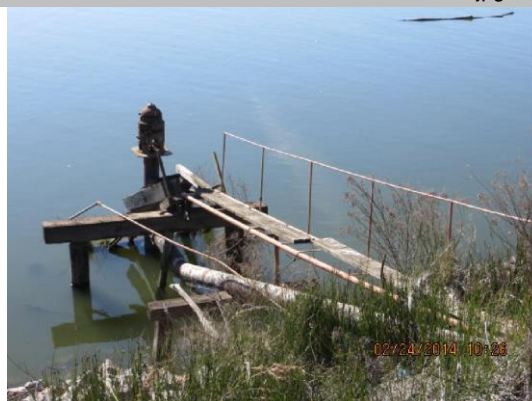
Comment Code						
Inspector Comment						
FS_ID:41643						
DS_ID:22231						
EP_NO: 1311						
Repair Type: Non-Urgent						
Crossing Status: Found						
UCIP Comments: Appears abandoned and if so should be done so properly. Walkway and pier falling apart.						
FIELD_STRUCT_DESC: 12-inch steel irrigation discharge pipe through the levee, invert elevation 7.8 feet below the crown. Pump on a pile structure in the river. 42-inch concrete standpipe and a meter pole at the landside (LS) toe. The 12-inch pipe appears to be sleeved with a 10-inch pipe, as it measures 10 inches on both slopes. 1.5-inch electrical conduit through the levee at the same location. (Plans for installing three pipes through the levee authorized under Permit No. 1311, 1948 - Joe Lopes). [Additional Reference(s): DWR Levee Log, 1993. USACE Sacramento O&M Manual 104, February 1960, (RM 20.37)].						
FS Date: 2/24/2014

Pump on structurally failing pier/walkway on WS toe.

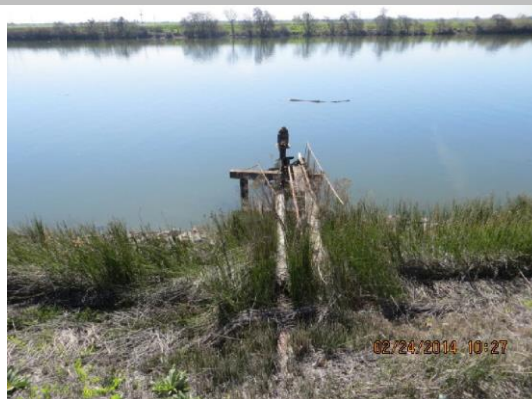
Pump on pier at WS toe.

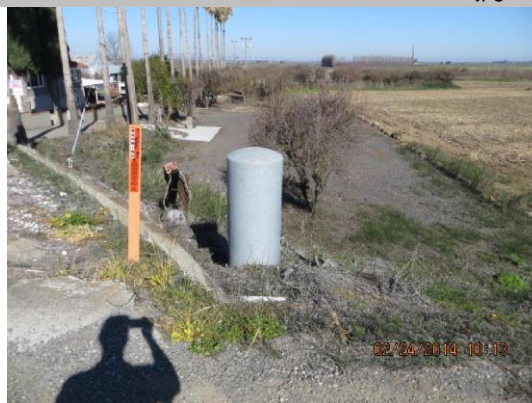
LM Start	5.59	Rating **	M	Issue No.	963
LM End	5.59	Issue Type +	En	Location *	
Category	Supplemental			GPS Latitude/Longitude	
				Start	End
Item	DWR UCIP Field Study			38.192581°	38.192581°
				-121.570807°	-121.570807°
DWR ID	22233				
Comment Code					
Inspector Comment					
FS_ID:40542 DS_ID:22233 EP_NO: 1311 Repair Type: Non-Urgent Crossing Status: Found UCIP Comments: Systed appears abandoned and if so, should be done so properly. FIELD_STRUCT_DESC: 2-inch galvanized iron domestic water line through the levee, 4 feet below the crown. Hand pump and pump on the waterside (WS) slope. Tank on the landside (LS) shoulder. (Plans for installing three pipes through the levee authorized under Permit No. 1311, 1948 - Joe Lopes). [Additional Reference(s): DWR Levee Log, 1993]. FS Date: 2/24/2014

Tank on LS shoulder.

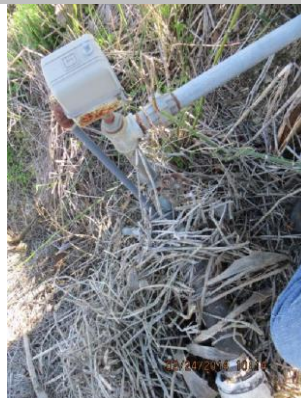
Valve next to tank on LS shoulder.

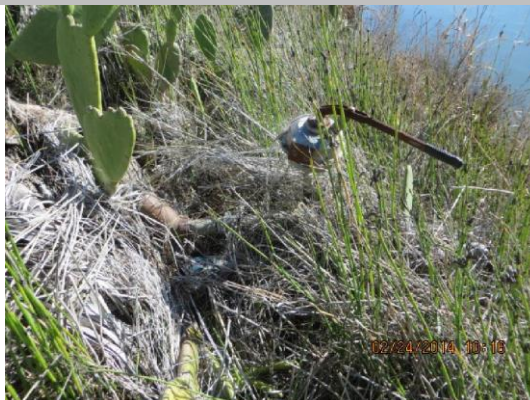
Hand pump and electric pump on WS slope.

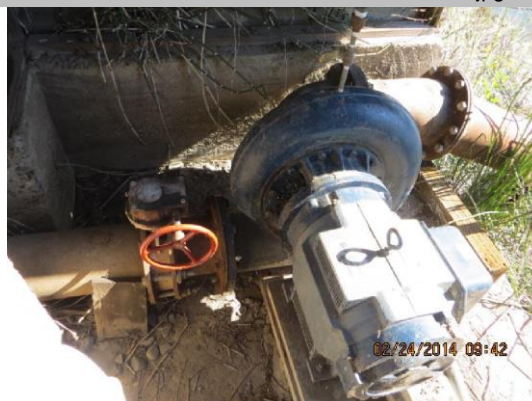
Photo 1 of 3 : UCIP\_FA\_2018\_30864\_56747.jpg

Pump and gate valve inside pumphouse on WS slope.

Comment Code						
Inspector Comment						
FS_ID:30864 DS_ID:22238 EP_NO: 9430 Repair Type: Non-Urgent Crossing Status: Found UCIP Comments: Annular space not grouted. FIELD_STRUCT_DESC: 12-inch steel irrigation discharge pipe through the levee, invert elevation 4 feet below the crown. 8-inch pipe sleeved through the 12-inch pipe. Pump and gate valve in a pump house and a vent on the waterside (WS) slope. Siphon breaker in a 16-inch corrugated metal pipe (CMP) riser on the landside (LS) shoulder. 4-foot concrete standpipe, power pole, and meter on the LS toe. (Retention of an irrigation pumping plant with a centrifugal pump and accessories in a corrugated metal shed on the WS slope above rock authorized under Automatic Board Order (ABO) issued as Permit No. 9430, 1974 - M. B. Millhauser). [Additional Reference(s): DWR Levee Log, 1993. USACE Sacramento O&M Manual 104, February 1960, (RM 20.99)]. FS Date: 2/24/2014

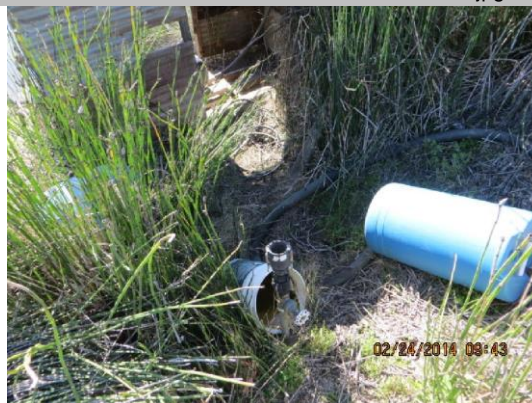
Photo 2 of 3 : UCIP\_FA\_2018\_30864\_56746.jpg

Vent next to pumphouse on WS slope.

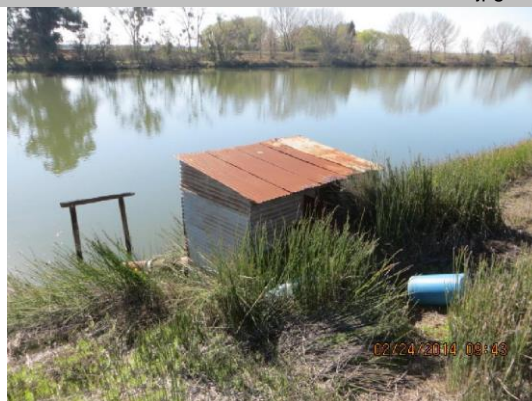
Photo 3 of 3 : UCIP\_FA\_2018\_30864\_56745.jpg

Pumphouse on WS slope.

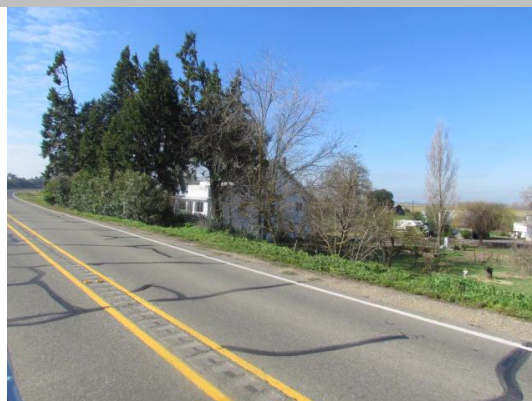
Photo 1 of 1 : FA\_2018\_RD0003\_25\_88\_20180925\_00073.jpg

LM Start	6.54	Rating **	M	Issue No.	88
LM End	6.57	Issue Type +	En	Location *	LS
Category	Earthen Levee			GPS Latitude/Longitude	
				Start	End
Item	Vegetation			38.201390°	38.201921°
				-121.558934°	-121.558866°
DWR ID	DWR_RD0003_02_s_2012_88				
Comment Code					
V6 : Landscaping					
Inspector Comment

Looking south at landscaping on landside shoulder.

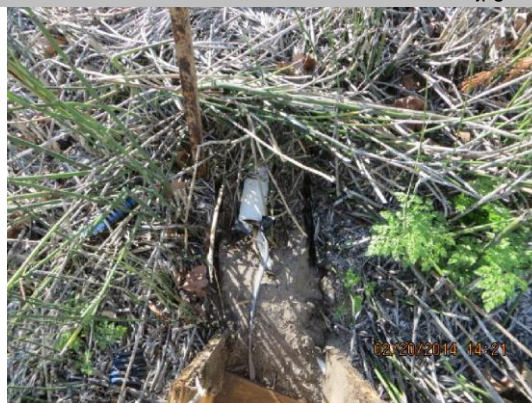
Photo 1 of 2 : UCIP\_FA\_2018\_31291\_57310.jpg

LM Start	6.54	Rating **	M	Issue No.	965	
LM End	6.54	Issue Type +	En	Location *		
Category	Supplemental			GPS Latitude/Longitude		
				Start	End	
Item	DWR UCIP Field Study			38.201393 °	38.201393 °	
				-121.558905 °	-121.558905 °	
DWR ID	24841					
Comment Code						
Inspector Comment						
FS_ID:31291						
DS_ID:24841						
EP_NO: N/A						
Repair Type: Non-Urgent						
Crossing Status: Found						
UCIP Comments: No permit identified for this crossing.						
FIELD_STRUCT_DESC: 2.5-inch polyvinyl chloride (PVC) conduit, 4 feet below the crown. 0.5-inch water line and electrical line sleeved through the conduit. Conduit provides service to a boat dock. This crossing was field discovered.						
FS Date: 2/20/2014

Pipe visible on WS slope.

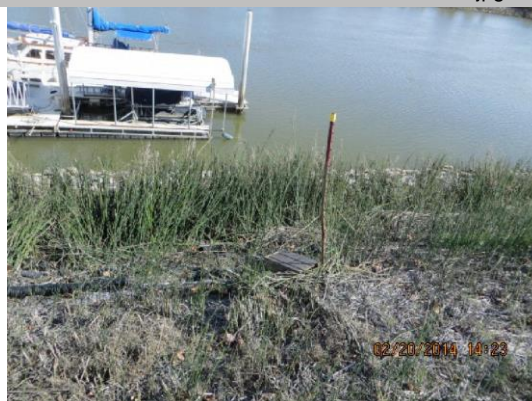
Photo 2 of 2 : UCIP\_FA\_2018\_31291\_57309.jpg

Pipe visible on WS slope.

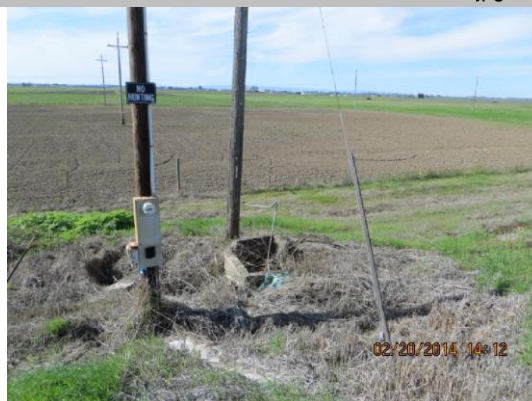
Photo 1 of 3 : UCIP\_FA\_2018\_30672\_56446.jpg

Concrete distribution box, power pole, and meter on LS toe.

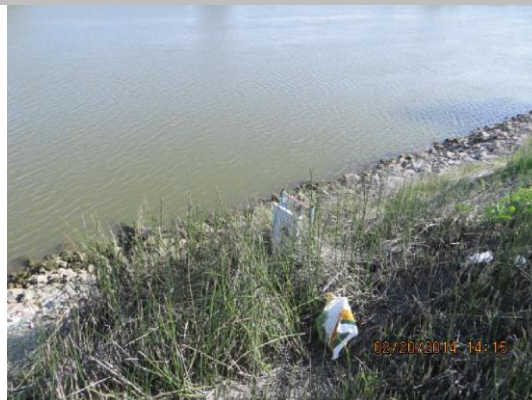
Photo 2 of 3 : UCIP\_FA\_2018\_30672\_56445.jpg

Pump in vegetation on WS slope.

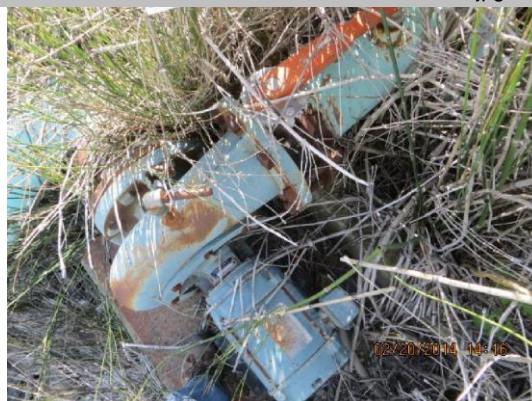
Photo 3 of 3 : UCIP\_FA\_2018\_30672\_56444.jpg

Comment Code						
Inspector Comment						
FS_ID:30672 DS_ID:22242 EP_NO: N/A Repair Type: Non-Urgent Crossing Status: Found UCIP Comments: Appears abandoned and if so should be done so properly. FIELD_STRUCT_DESC: *ABANDONED* 7-inch steel irrigation discharge pipe through the levee, invert elevation 7.6 feet below the crown. Pump in a pump house on a concrete pad on the waterside (WS) slope. Gate valve on the WS slope. 44-inch by 44-inch concrete distribution box, joint pole (JP), and meter at the landside (LS) toe. [Additional Reference(s): DWR Levee Log, 1993. USACE Sacramento O&M Manual 104, February 1960, (RM 21.58)]. FS Date: 2/20/2014

Pump on pad with butterfly valve on WS slope.

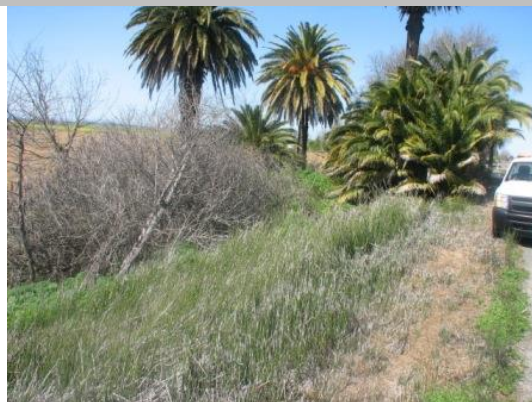
Photo 1 of 3 : FA\_2018\_RD0003\_25\_12\_20180925\_00015.jpg

LM Start	6.88	Rating **	U	Issue No.	12
LM End	6.90	Issue Type +	En	Location *	LS
Category	Earthen Levee			GPS Latitude/Longitude	
				Start	End
Item	Vegetation			38.206363 °	38.206598 °
				-121.558520 °	-121.558530 °
DWR ID	DWR_RD0003_02_s_2012_12				
Comment Code					
V6 : Landscaping					
Inspector Comment					
Palm trees on landside slope.

Dense trees at landside toe and shoulder.

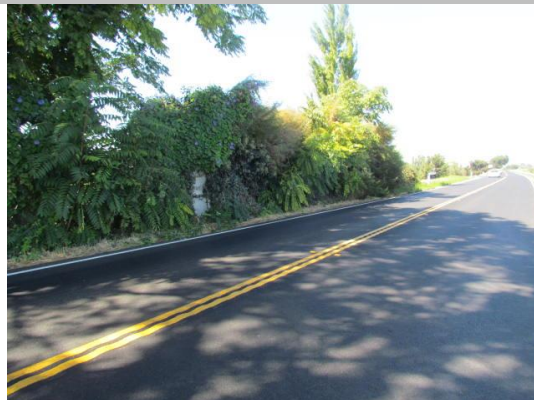
Photo 1 of 1 : FA\_2018\_RD0003\_25\_55\_20180925\_00041.jpg

LM Start	7.22	Rating **	U	Issue No.	55
LM End	7.22	Issue Type +	En	Location *	LS
Category	Earthen Levee			GPS Latitude/Longitude	
				Start	End
Item	Vegetation			38.211357 °	38.211357 °
				-121.558468 °	-121.558468 °
DWR ID	DWR_RD0003_02_s_2012_55				
Comment Code					
V6 : Landscaping					
Inspector Comment

Looking northwest at dense landscaping on landward shoulder and slope.

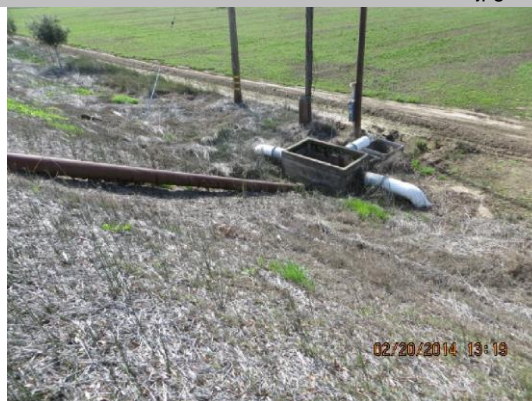
Photo 1 of 3 : UCIP\_FA\_2018\_30648\_56414.jpg

Pipe visible on LS slope with concrete distribution box on LS toe.

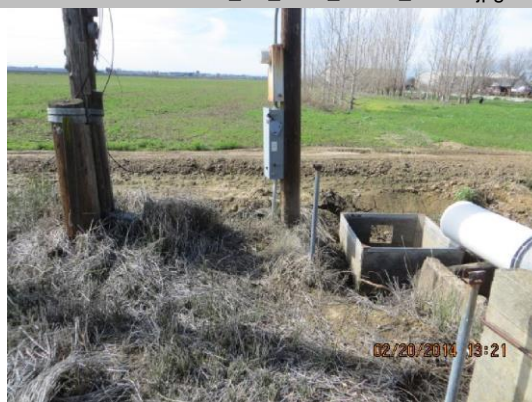
Photo 2 of 3 : UCIP\_FA\_2018\_30648\_56413.jpg

Meter on pole next to concrete distribution box on LS toe.

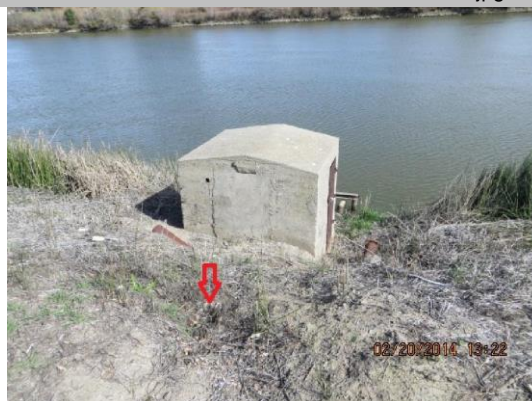
Photo 3 of 3 : UCIP\_FA\_2018\_30648\_56412.jpg

Comment Code						
Inspector Comment						
FS_ID:30648 DS_ID:22247 EP_NO: 1383 Repair Type: Non-Urgent Crossing Status: Found UCIP Comments: 44-inch deep hole on WS slope over pipe 3-inches in diameter. FIELD_STRUCT_DESC: 12-inch steel irrigation discharge pipe through the levee, invert elevation 4 feet below the crown. Concrete pump house on the waterside (WS) slope. 5-foot by 7-foot concrete distribution box at the landside (LS) toe with a pole and meter. (Plans for the installation of an irrigation pumping plant and a 12-inch steel discharge pipe through the levee authorized under Permit No. 1383, 1949 - Kate A. Berlin and Frank L. Fallman). [Additional Reference(s): DWR Levee Log, 1993. USACE Sacramento O&M Manual 104, February 1960, (RM 22.33)]. FS Date: 2/20/2014

Concrete pump house on WS shoulder with hole over pipe on WS slope.

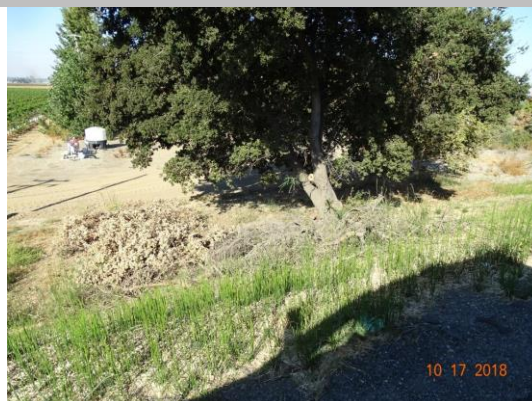
Photo 1 of 1 : FA\_2018\_RD0003\_25\_190\_20181018\_00302.jpg

LM Start	7.41	Rating **	M	Issue No.	190
LM End	7.41	Issue Type +	En	Location *	LS
Category	Earthen Levee			GPS Latitude/Longitude	
				Start	End
Item	Encroachments			38.214065 °	38.214065 °
				-121.558613 °	-121.558613 °
DWR ID	DWR_RD0003_02_s_2018_190				
Comment Code					
TR : Tree or limb					
Inspector Comment

View of tree limbs on the land side slope (October 2018).

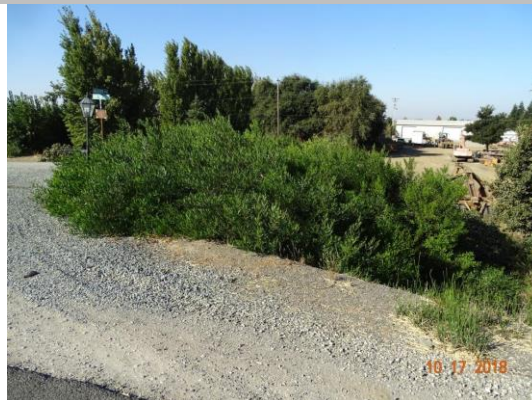
Photo 1 of 1 : FA\_2018\_RD0003\_25\_189\_20181018\_00301.jpg

LM Start	7.43	Rating **	U	Issue No.	189
LM End	7.43	Issue Type +	En	Location *	LS
Category	Earthen Levee			GPS Latitude/Longitude	
				Start	End
Item	Vegetation			38.214308 °	38.214308 °
				-121.558654 °	-121.558654 °
DWR ID	DWR_RD0003_02_s_2018_189				
Comment Code					
V6 : Landscaping					
Inspector Comment

View of landscape vegetation on the land side slope (October 2018).

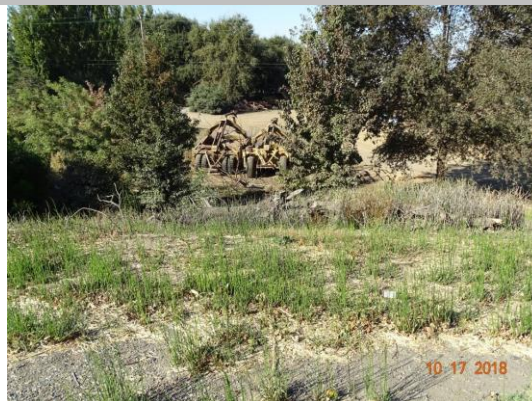
Photo 1 of 1 : FA\_2018\_RD0003\_25\_198\_20181018\_00300.jpg

View of tree at the top of the land side slope (October 2018).

LM Start	7.44	Rating **	M	Issue No.	198
LM End	7.44	Issue Type +	En	Location *	LS
Category	Earthen Levee			GPS Latitude/Longitude	
				Start	End
Item	Encroachments			38.214553 °	38.214553 °
				-121.558618 °	-121.558618 °
DWR ID	DWR_RD0003_02_f_2018_198				
Comment Code					
TR : Tree or limb					
Inspector Comment					
Remove tree from landside slope.

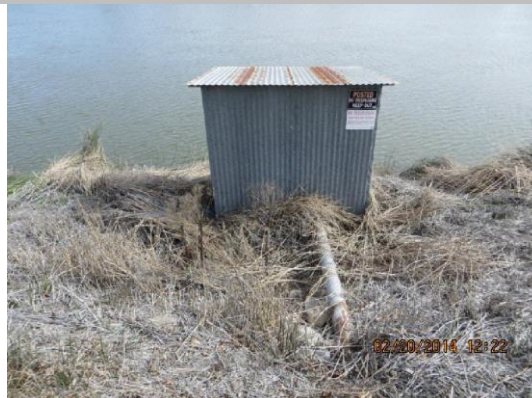
Photo 1 of 3 : UCIP\_FA\_2018\_30643\_56402.jpg

Pumphouse on WS slope.

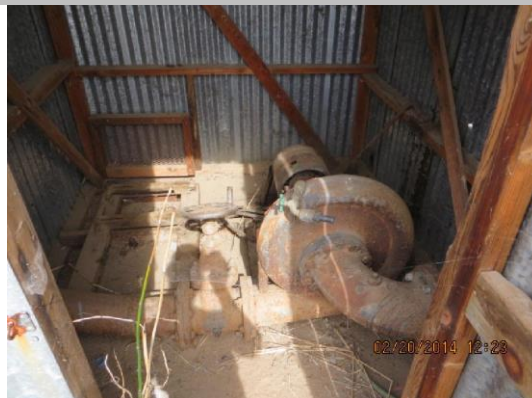
Photo 2 of 3 : UCIP\_FA\_2018\_30643\_56401.jpg

Pump, gate valve and pipe visible in pumphouse on WS slope.

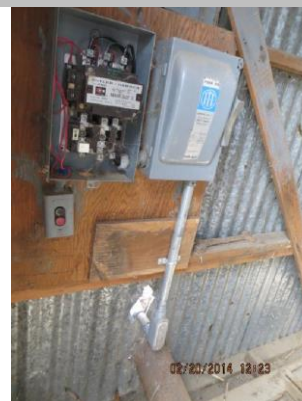
Photo 3 of 3 : UCIP\_FA\_2018\_30643\_56400.jpg

Comment Code						
Inspector Comment						
FS_ID:30643 DS_ID:22249 EP_NO: N/A Repair Type: Non-Urgent Crossing Status: Found UCIP Comments: Appears abandoned and if so should be done so properly. FIELD_STRUCT_DESC: 6-inch steel irrigation discharge pipe through the levee, invert elevation 3.5 feet below the crown. Pump and gate valve in a pump house on the waterside (WS) slope. 36-inch concrete standpipe on the landside (LS). 1.5-inch electrical conduit through the levee at the same location. Power pole and meter on the LS slope. (L. Souza). [Additional Reference(s): DWR Levee Log, 1993. USACE Sacramento O&M Manual 104, February 1960, (RM 22.60)]. FS Date: 2/20/2014

Electrical panel inside pumphouse on WS slope.

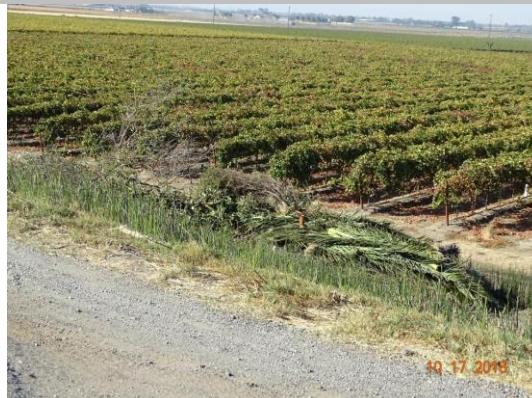
Photo 1 of 1 : FA\_2018\_RD0003\_25\_177\_20181018\_00299.jpg

LM Start	8.01	Rating **	M	Issue No.	177
LM End	8.01	Issue Type +	En	Location *	LS
Category	Earthen Levee			GPS Latitude/Longitude	
				Start	End
Item	Encroachments			38.222673 °	38.222673 °
				-121.557539 °	-121.557539 °
DWR ID	DWR_RD0003_02_f_2017_177				
Comment Code					
PR : Prunings					
Inspector Comment

View of prunings on the land side slope (October 2018).

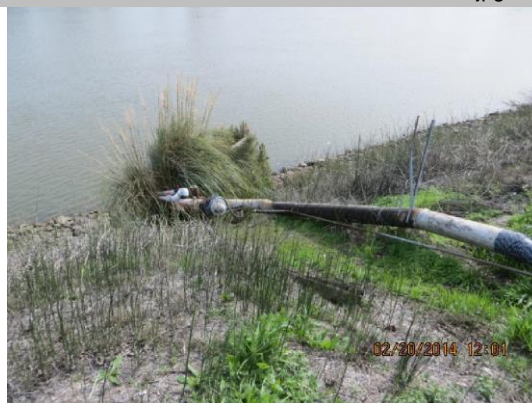
Photo 1 of 2 : UCIP\_FA\_2018\_30623\_56381.jpg

Comment Code					
Inspector Comment					
FS_ID:30623 DS_ID:22251 EP_NO: 886 Repair Type: Non-Urgent Crossing Status: Found UCIP Comments: Erosion under pipe on LS slope. FIELD_STRUCT_DESC: 10-inch steel irrigation discharge pipe through the levee, invert elevation 3.8 feet below the crown. Slant pump on the waterside (WS) slope. 36-inch concrete standpipe at the landside (LS) toe with a filter plant. Service pole on the LS slope. 1.5-inch steel electrical conduit through the levee at the same location. (Plans for the installation and maintenance of an irrigation pumping plant, including an 8-inch discharge pipe through the levee authorized under Permit No. 886, 1942 - Georgia McKuen. Retention of an irrigation pumping plant with a slant pump and a 10-inch steel pipe through the levee above the floodplain and a service pole near the LS shoulder authorized under Automatic Board Order (ABO) issued as Permit No. 9437, 1974 - Joseph Green Jr. [Additional Reference(s): DWR Levee Log, 1993, 12-inch pipe referenced. USACE Sacramento O&M Manual, February 1960, (RM 22.96)]. FS Date: 2/20/2014

Pipe and slant pump on WS slope.

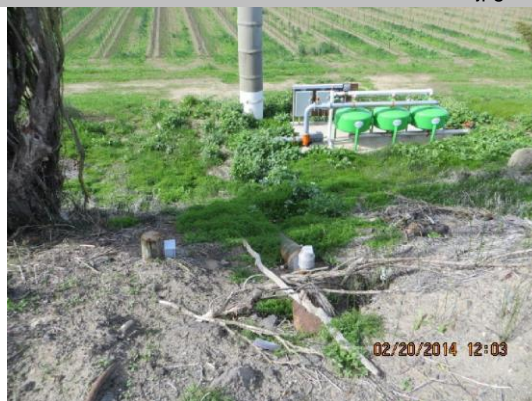
Photo 2 of 2 : UCIP\_FA\_2018\_30623\_56380.jpg

vent, pipe, standpipe, and filter plant on LS.
